# **Building Performance Evaluation**

**Reid Textile Dye Lab and Print Room monitoring**

Msc. Environmental Architecture

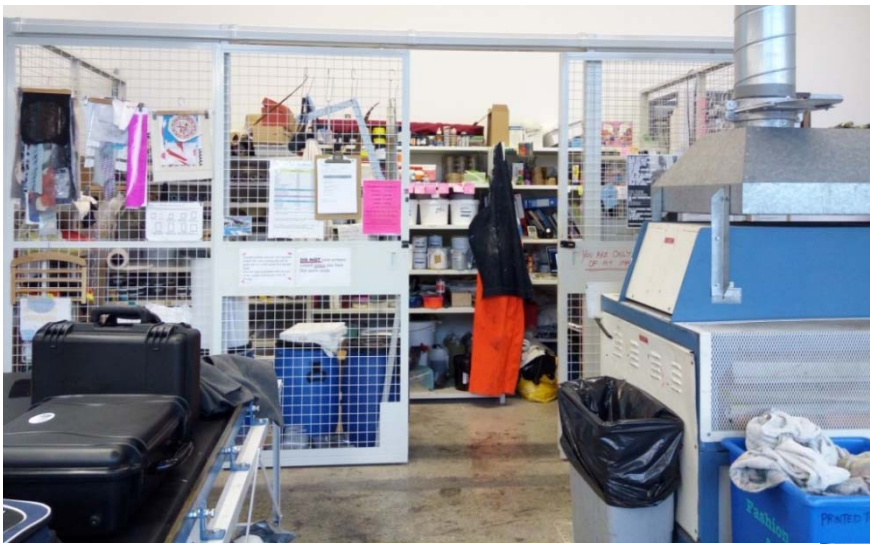
Figure1 : Lab Technician's cage has a door opening on the longer side. The heat press is directly placed opposite this entrance

The heat press could be moved to the corner of the space, to prevent it from obstructing the central path.

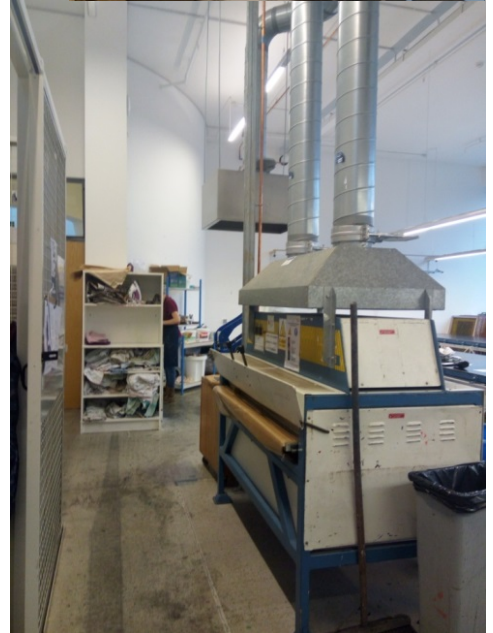
Figure 3: Heat press with overhead exhaust system. They are planning to shift it against the wall in place of the shelf due to its inconvenient location.

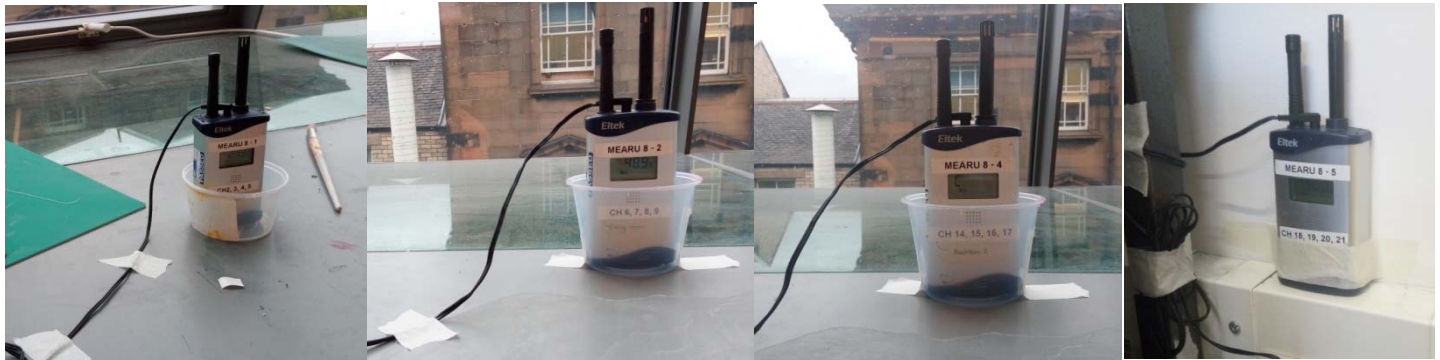
Four Carbon dioxide sensors were also installed in the Print room. Three were installed along the north wall on the deep window sill. One was installed adjacent to the technician's cage.

The three sensors were placed in plastic containers stuck to the sill using double sided tape, in order to avoid damage that may be caused due to spillage of dyes. The wires were secured to the sill using masking tape. The sensor near the cage was fixed over a plastic channel and was secured to the wall using masking tape.
