LV-8 Daylight Credit study

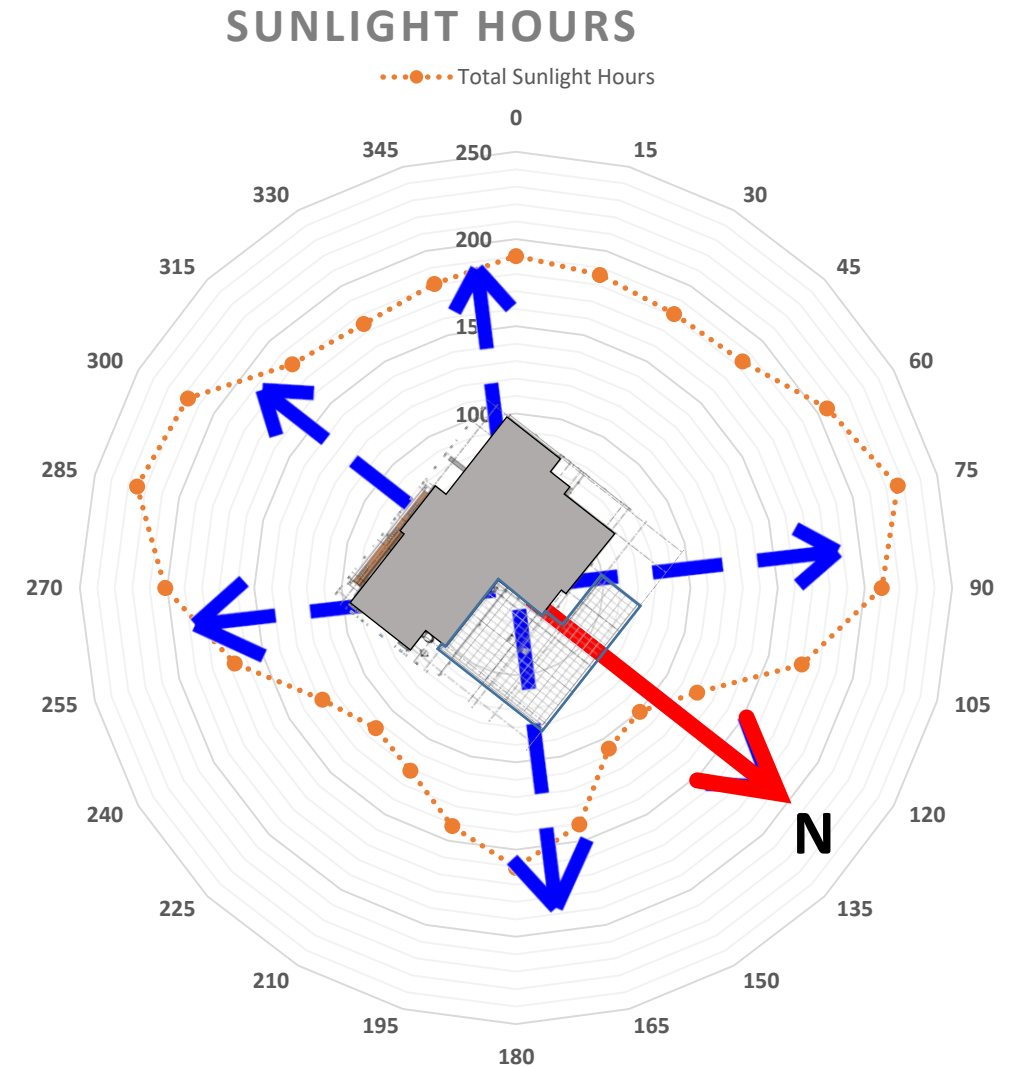
Fig 1 : Orientation Study – Sunlight Hours

An initial Sunlight hour analysis was carried out for 24 orientations at an interval of 15° to determine the worst case orientation. The sunlight analysis was carried out to find the number of monthly hours with maximum area of direct incident solar radiation. The orientation where the north direction was rotated to 128° from vertical axis had the lowest number of sunlight hours at 110 hours. This orientation was taken as the worst case orientation for the daylighting study.

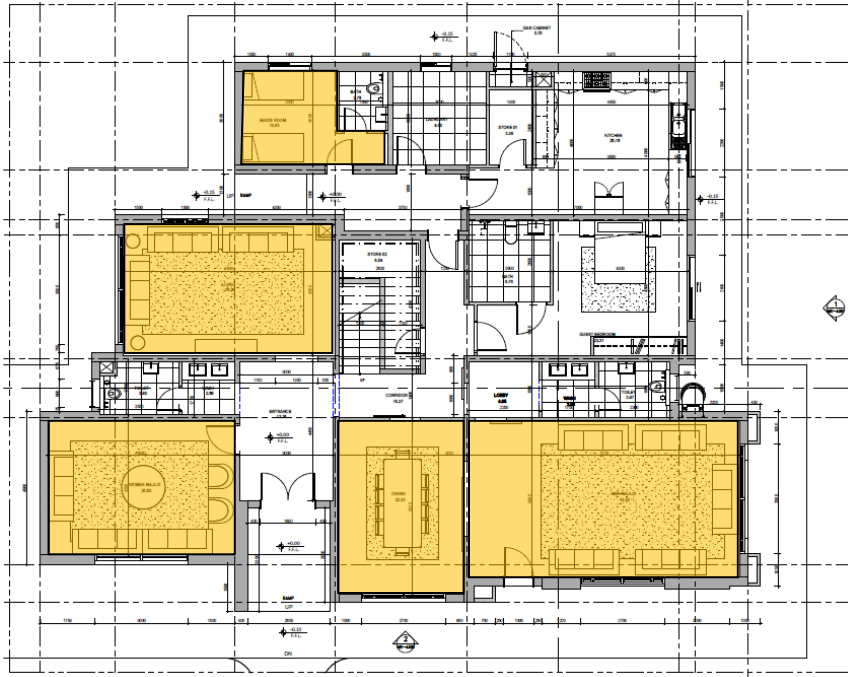
Fig 3 : Ground floor Plan

Villa Regularly Occupied Spaces	
Men Majlis	Ground Floor
Dining	Ground Floor
Living Room	Ground Floor
Women's Majlis	Ground Floor
Guest Bedroom	Ground Floor
Maid's room	Ground Floor
Bedroom 1	First Floor
Bedroom 2	First Floor
Bedroom 3	First Floor
Master Bedroom	First Floor
Living	First Floor

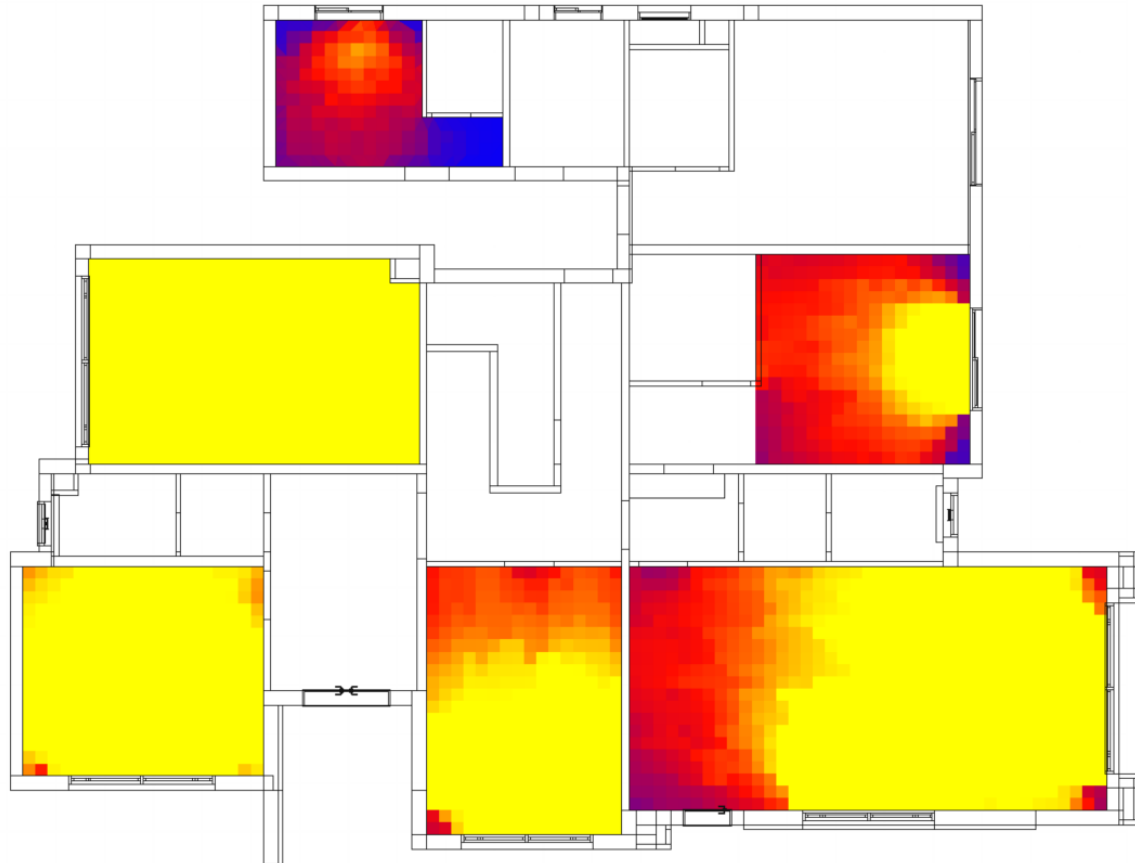
Ground floor

- Daylight Simulation was carried out for the **Spring Equinox (March 21st) 10am, 12pm, & 2pm** using Radiance as simulation engine with Grasshopper & Honeybee Interface.
- The Grid size for the daylight simulation is taken as 0.25mX0.25m.
- All occupied spaces were considered for the daylight study including all bedrooms & living, dining & Majlis areas.
- The plans below have occupied areas marked for reference. (summarised in Table 1.)
- **Glazing Transmittance** : Since Double Glazed Units are used through out the project with low Solar Heatgain Coefficient (SHGC), the VLT for the project is taken as 40% as it is feasible to achieve this VLT.
- **Interior Reflectances**: The Interior surface reflectances assigned to the internal surfaces are as per Table 2

March 21st 2021 10AM

- The above highlighted in yellow are the spaces that do not comply with the credit requirements.
- Even through the villa over all area comply with 250lux threshold the individual spaces fail to meet the requirements.
- The reason for these non-compliances is constraint of an existing design with deep spaces and no opportunity for provision for exterior windows.

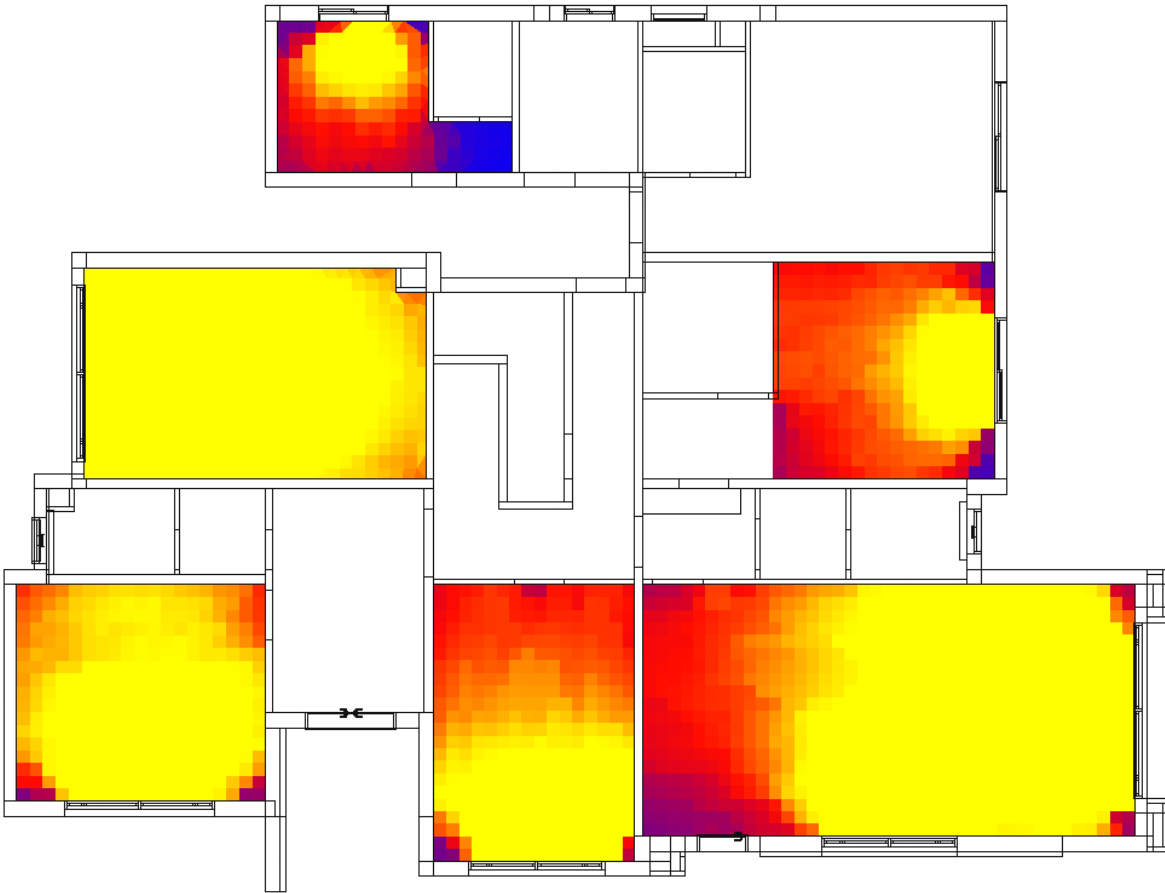
Ground floor

March 21st 2021 12PM

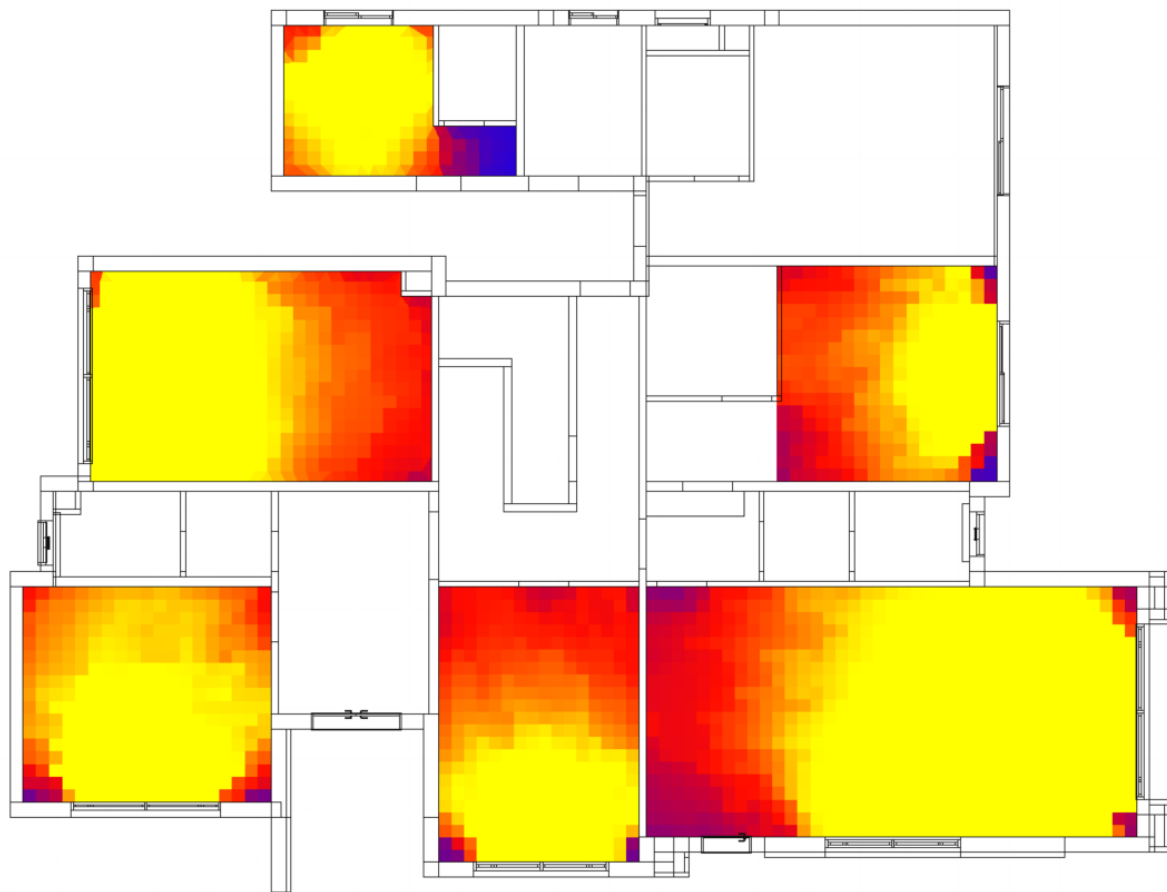
Ground floor

March 21st 2021 2PM
